# Face to Face

THE SEALING TECHNOLOGY MAGAZINE

# Oil & Gas Platform Gets More Reliable Seals

# TECHNICAL ADVICE HELPS KEEP FDA Qualification on Track

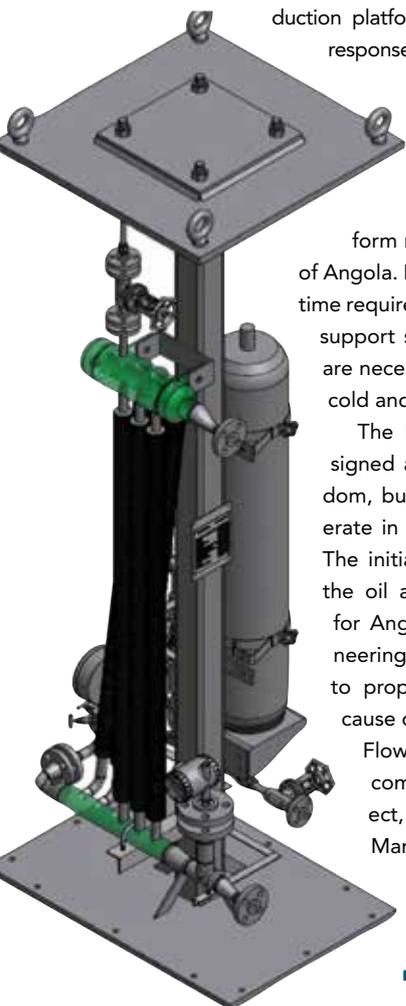
◀ Construction materials included 316 stainless steel for the air fin coolers on the Plan 53B seal support system, shown here, for an international oil and gas customer's new floating production, storage, and offloading platform.

To address the abundant exposure to sea water, the construction materials included 316 stainless steel for the air fin coolers on the Plan 53B seal support system. The seal flush plan support system can accommodate the arid climate location near Angola and the constant cooling breeze present at the location where the new platform resides.

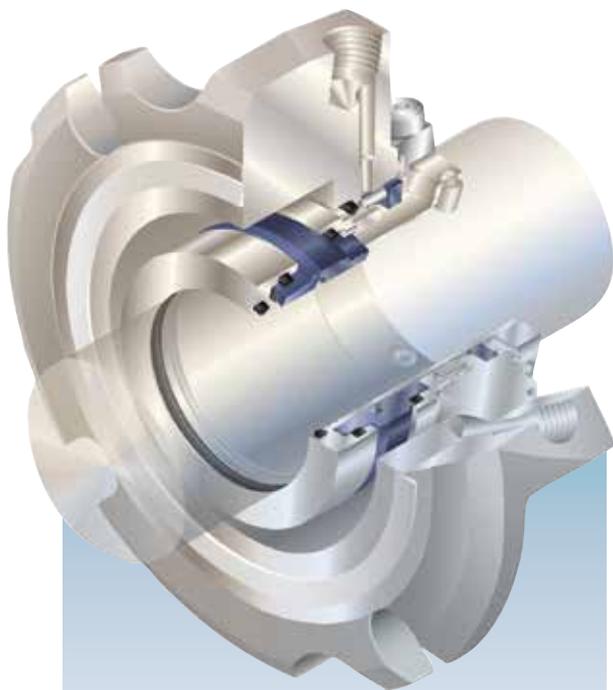
Two ISC2 cartridge seals with diamond-coated faces now are in operation at the wastewater plant, one for recirculating and the other for filling the recessed impeller slurry pump.

Neamtu suggested a UNCD coating on a single pusher Flowserve Innovative Standard Cartridge mechanical seal, model ISC2, with silicon carbide faces. "The ISC2 is a very rugged seal, and diamond-coated faces are better because of the reduction in heat gener-

The maintenance supervisor and staff have been pleasantly surprised by the performance of the seal in this demanding service, and they intend to use diamond-coated faces on all mechanical seal applications. Currently, two ISC2 seals with diamond-coated faces are in operation; one for recirculating and the other for filling the recessed impeller slurry pump. A third seal was purchased and installed on the spare pump.

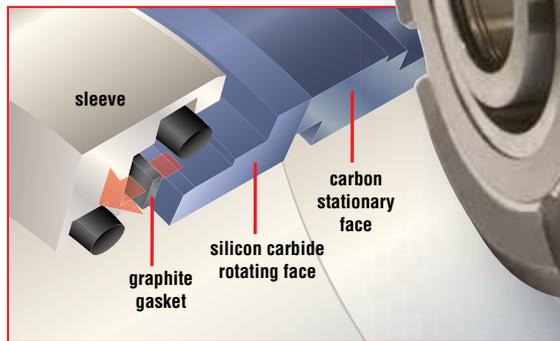
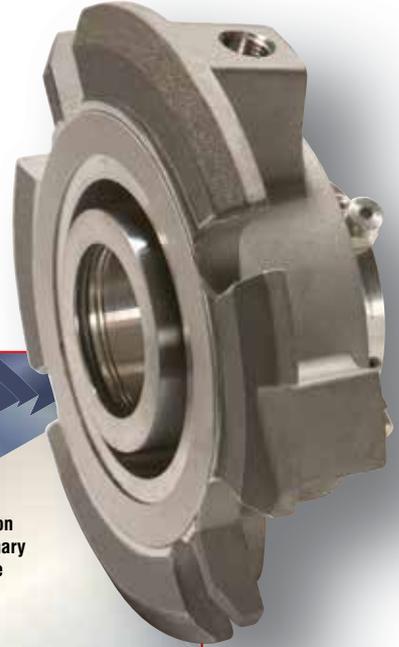
## ISC2 seals tolerate dry running events with exclusive thermal management technology

- Thermally conductive and mechanically compliant graphite material dramatically improves heat transfer between the silicon carbide rotating seal face and the sleeve
- The sleeve acts as a heat sink, lowering seal face operating temperatures and transforming cavitating and dry running bad actors into highly reliable installations

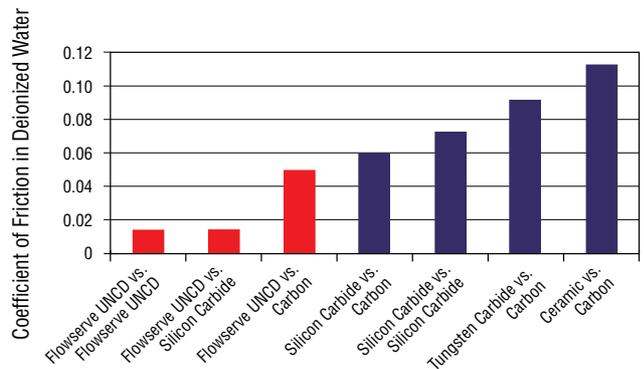
## Flowserve diamond coated silicon carbide offers the lowest coefficient of friction for cool operation

- The lowest friction of any seal face material provides cool running seal faces in poor lubricity fluids such as hot water
- Maximum resistance to abrasive particle damage
- The highest chemical resistance of all seal face materials enables its use in aggressive acids, alkalines, and caustics
- High wear resistance brings forgiveness for off-design operation such as intermittent dry running
